Manhole Inspection Summary

Manhole # S21GG2015MH

Insp Date: **11/15/06 10:12 AM**

Location Address: **1108 BELLEMORE RD**

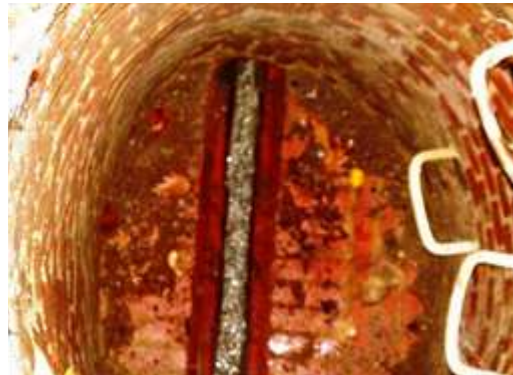
Top View

Bench debris.

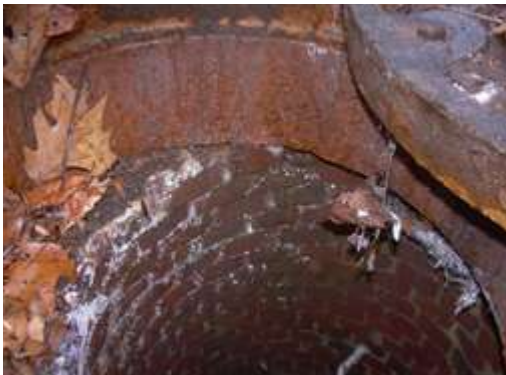
Defect

Frame Offset: **3** (in.) Condition: ☒ Sound ☐ Cracked ☐ Leaks

Condition: ☐ Sound ☐ Cracked ☐ Root Intrusion ☐ Loose Brick ☒ **Deteriorated**

Infiltration: ☐ None ☒ **Joint** ☐ Cracks ☒ **Mortar** ☐ Roots ☐ Wall

Frame offset. Corbel deterioration and infiltration.

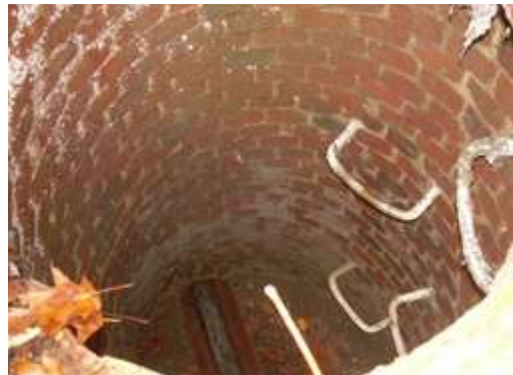
Defect

Infiltration: ☐ None ☐ Joint ☐ Cracks ☐ Mortar ☐ Roots ☒ **Wall**

Corbel and Barrel infiltration.

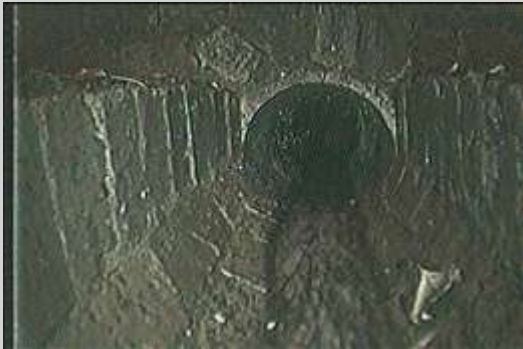
8 in. Circular Gravity Sewer Pipe Out @ 12 O'Clock

Infiltration: **None** Pipe Seal Cond: **Cracked**
